## **John B. Nicosia Senior Housing - 4720 Railroad Avenue**

Preliminary Findings Related to Column Distress  
WJE No. 2021.4581

**4720 Railroad Avenue - Column Distress**

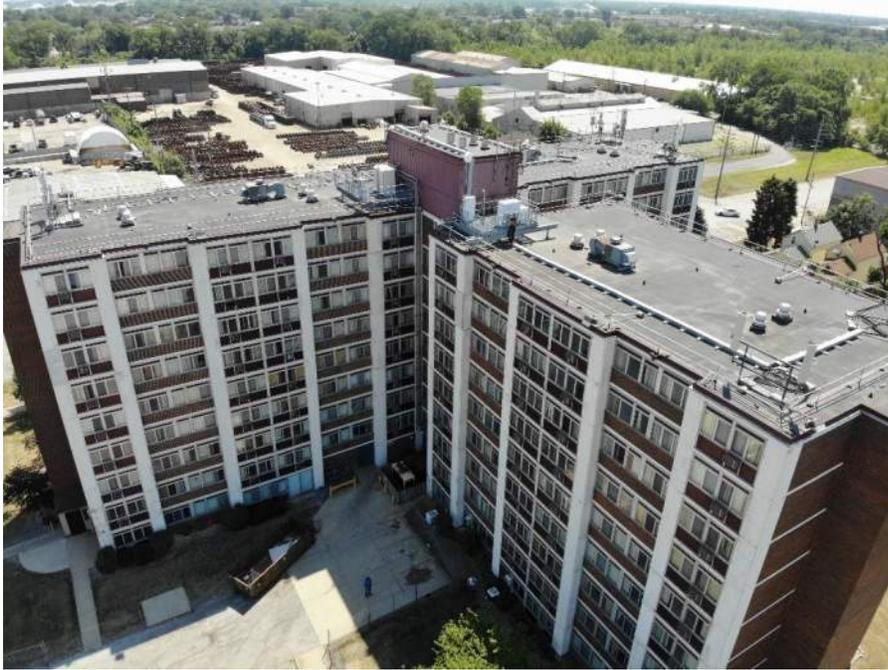
Figure 1. Overall view of complex looking southeast

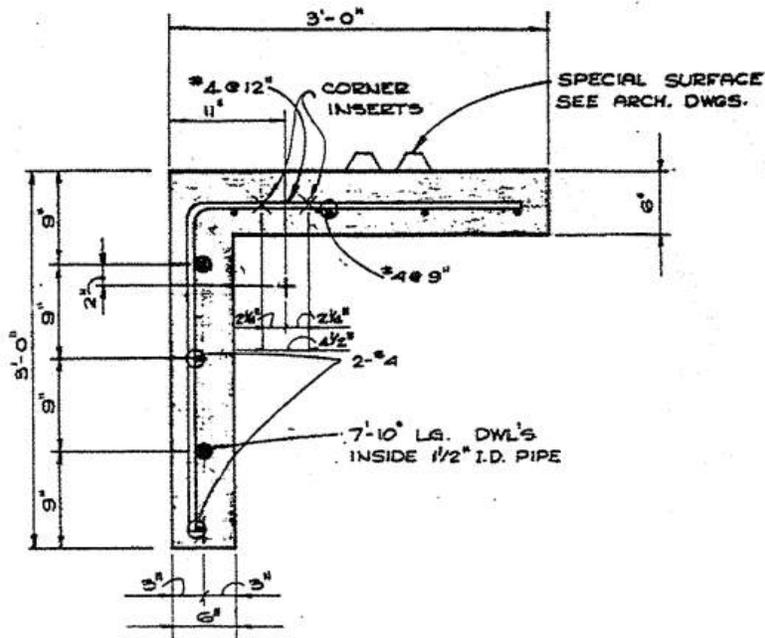
Figure 2. Typical column cross section from original structural drawings

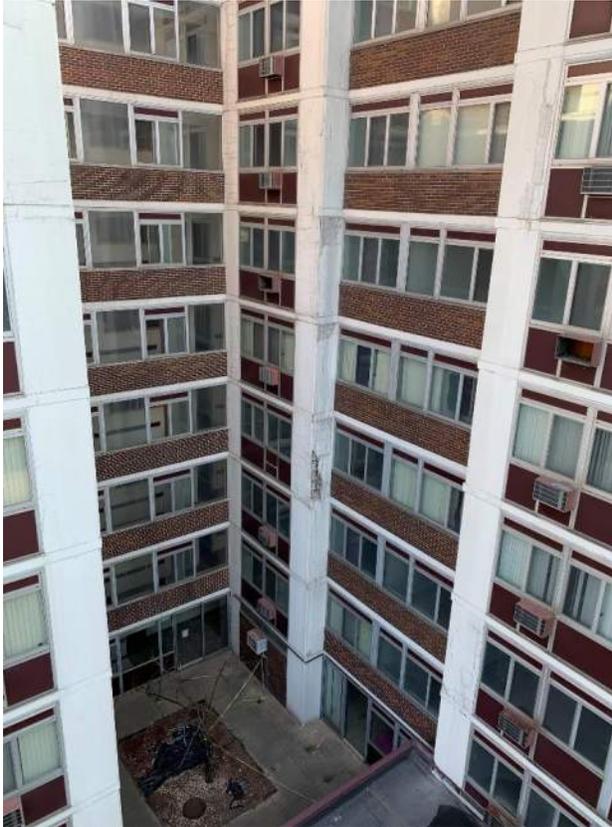
1. Based upon visual observations, WJE categorized each of the exterior columns into three condition ranges, A, B, and C as described below:
  - a. **Condition A** – Columns with little-to-no visually- or audibly-perceptible signs of distress.

- b. **Condition B** – Columns with scattered visible cracking and small areas of audibly-perceived delamination, but no visually obvious delaminations or spalls.

- c. **Condition C** – Columns with widespread cracking, splitting, and incipient spalling.
2. While we are still reducing our field data at this time, about 25 percent of the columns were judged as Condition A, about 40 percent were Condition B, and about 35 percent were deemed Condition C. Plywood enclosures had been installed at about 15 separate column locations, presumably to mitigate falling hazards from advanced deterioration. These columns were all assigned to Condition C.

Figure 3. Typical column runs showing variable conditions, west facade of south wing

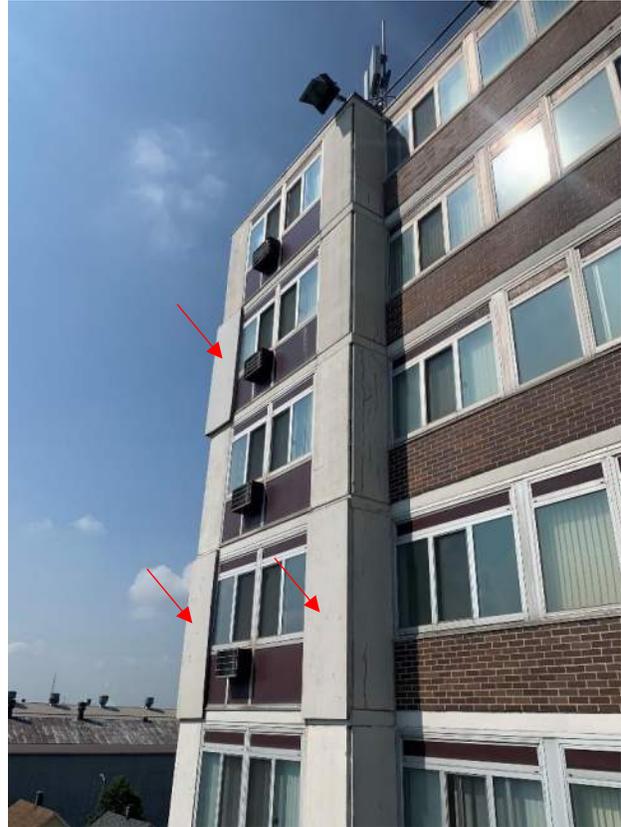
Figure 4. Plywood enclosures, east facade of south wing

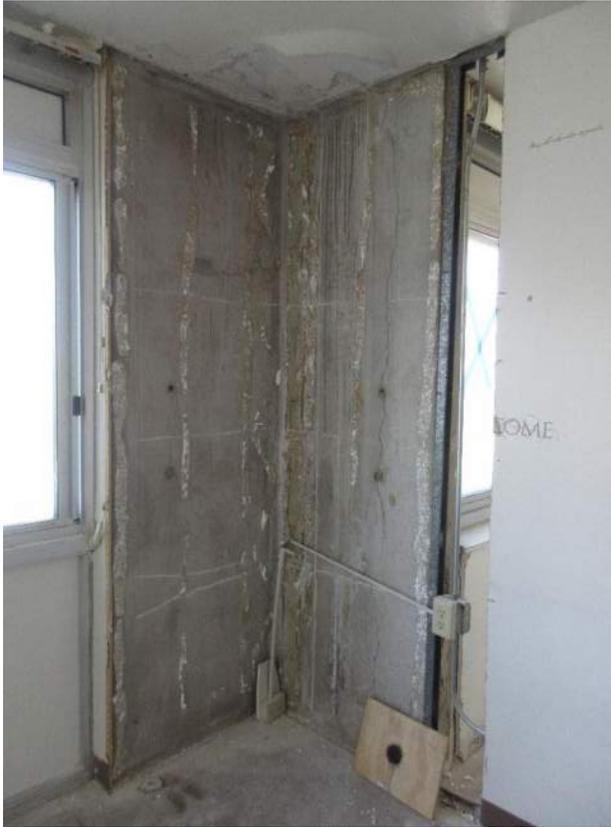
Figure 5. Inside face of typical exterior column after finishes removed

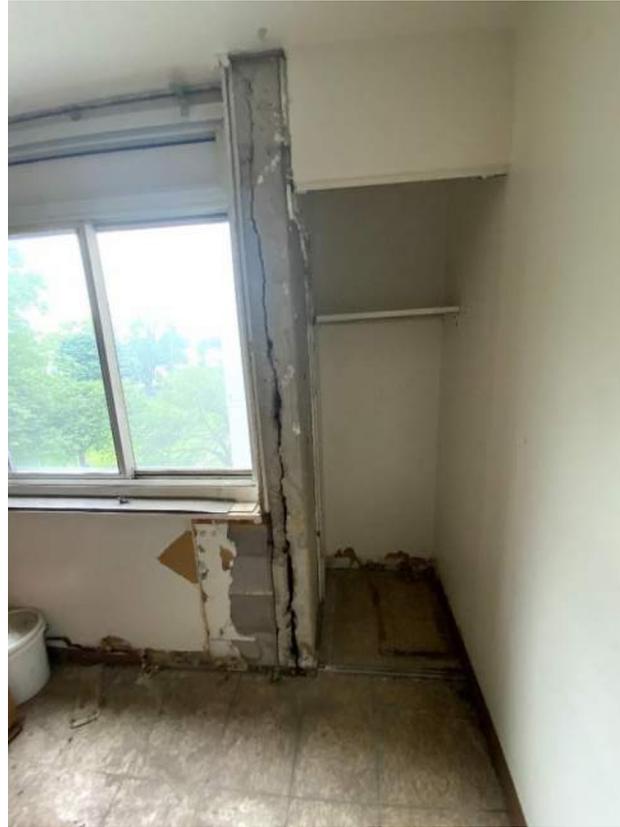
3. WJE has not yet reviewed the interior columns, but we suspect that they are in better condition due to the lack of moisture exposure.
4. The observed deterioration in the exterior columns is due to corrosion of the embedded reinforcing steel in the columns, likely accelerated by the presence of chlorides in the concrete. WJE is in the process of confirming this through laboratory testing. As the reinforcing steel within the columns corrodes, it expands, pushing outward and exerting force on the concrete surrounding the reinforcing steel, causing the concrete to crack and split, or delaminate. These cracks within the concrete then allow more moisture to reach the reinforcing steel, speeding up the deterioration. The thin geometry of the wall columns (only 6 inches thick) combined with the lack of confinement reinforcement (only one layer of reinforcement centered on the wall) means that a delamination or separation at the reinforcing steel greatly reduces the axial capacity of the column.

Figure 6. Cracking at interior face of column

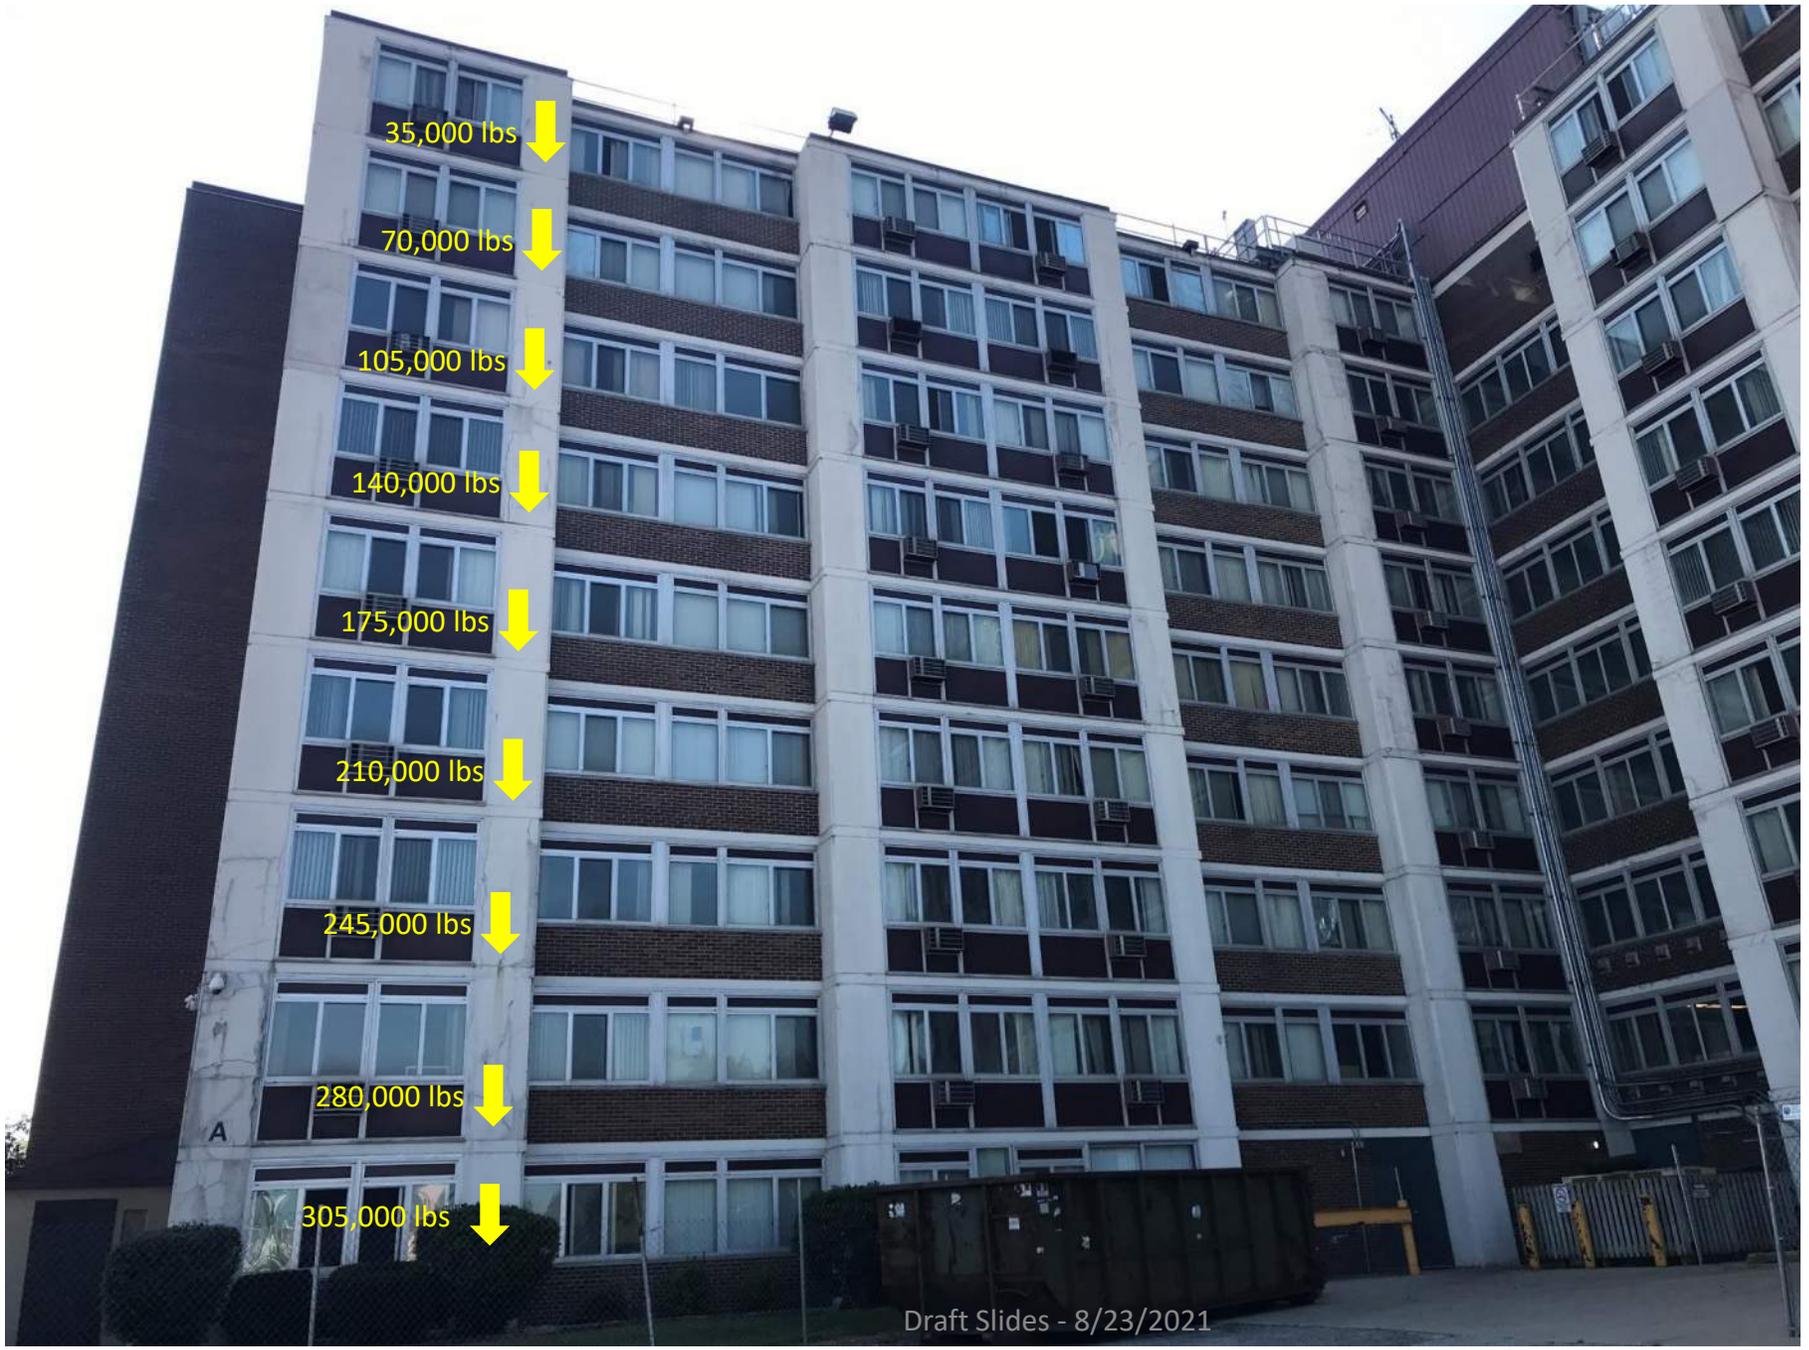
5. Our initial calculations, regarding gravity loads only, indicate that each of the most heavily-loaded exterior columns are required to support approximately 35,000 pounds of unfactored dead load at each floor level from the floor slab and exterior cladding, which results in about 300,000 pounds of unfactored load at the ground floor. Many of the Type B and C columns have experienced deterioration that has compromised their ability to safely support these loads.

35,000 lbs ↓

70,000 lbs ↓

105,000 lbs ↓

140,000 lbs ↓

175,000 lbs ↓

210,000 lbs ↓

245,000 lbs ↓

280,000 lbs ↓

305,000 lbs ↓

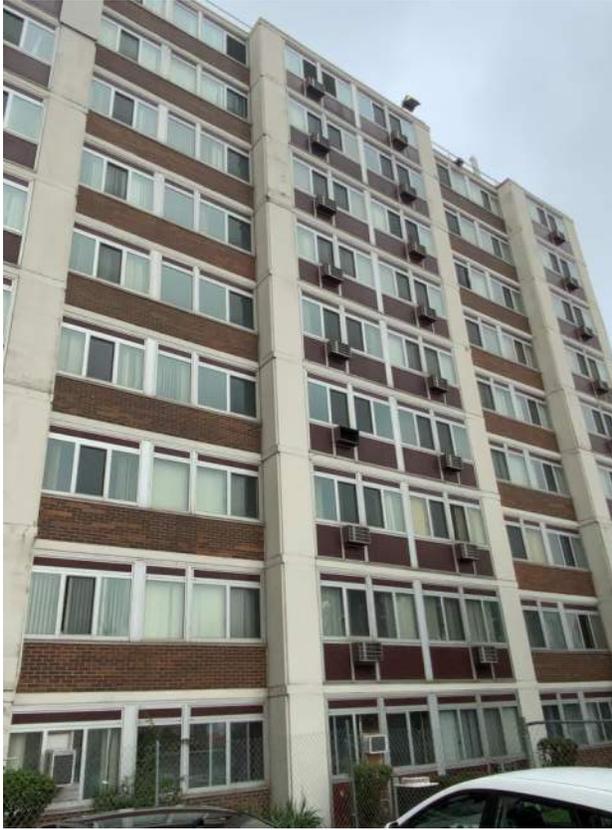
Figure 1. Representative building facade

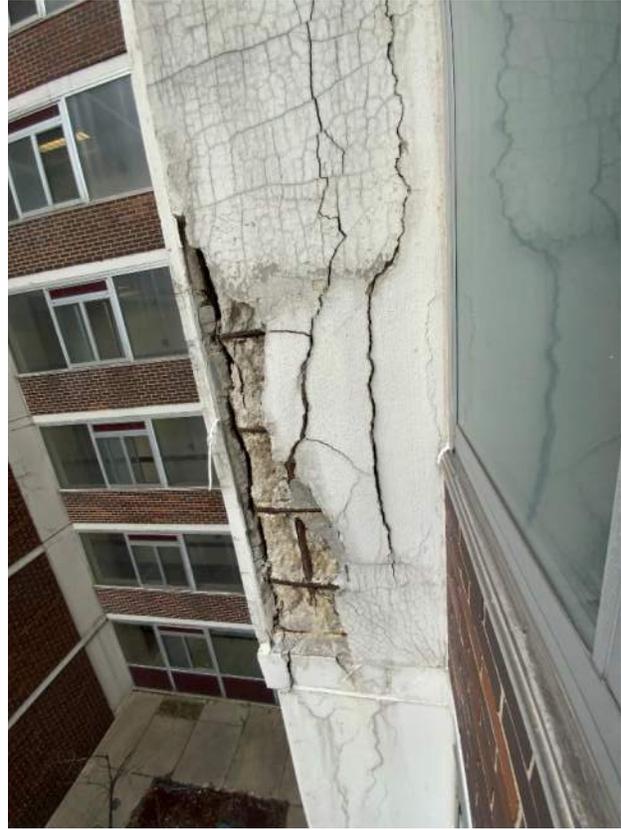
Figure 2. Spalled concrete at L-shaped column

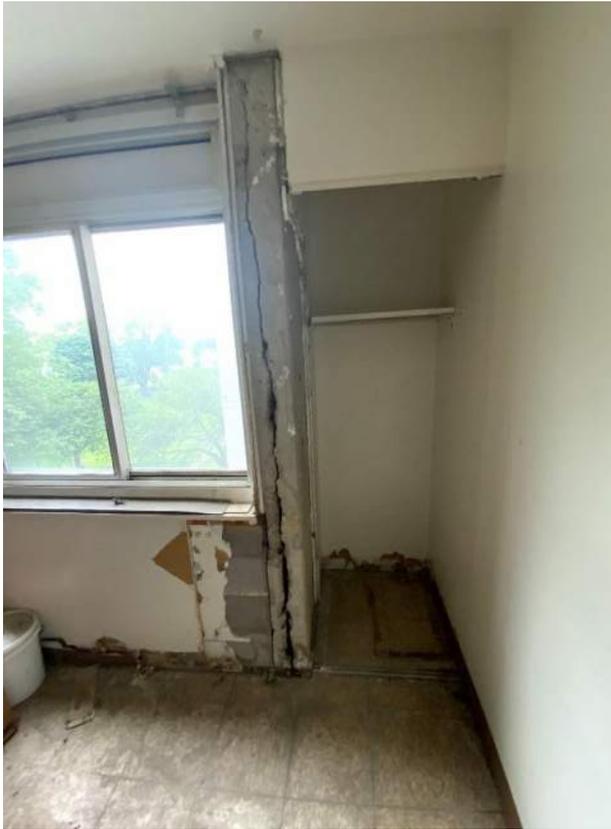
Figure 3. Cracking at L-shaped column

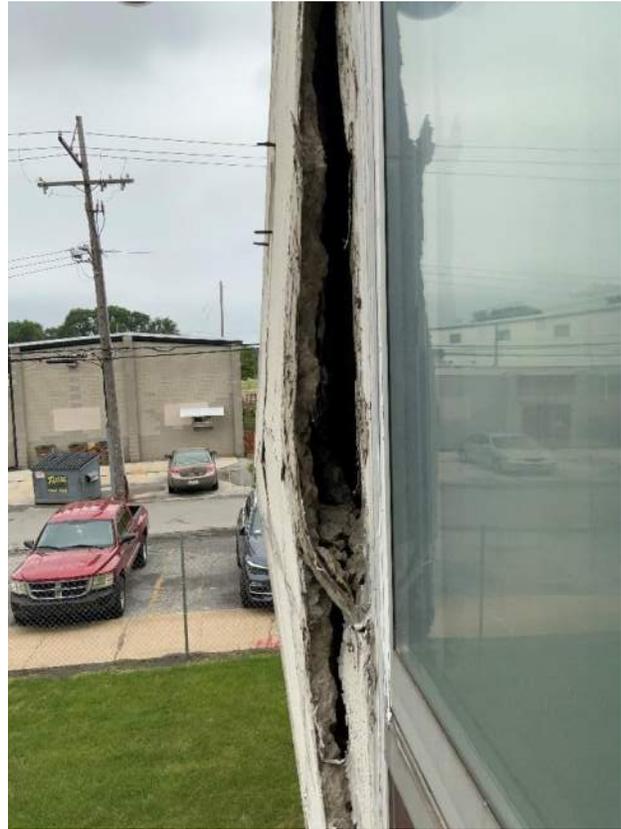
Figure 4. Spalled and bowed concrete
