## **John B. Nicosia Senior Housing - 4720 Railroad Avenue**

Preliminary Findings Related to Column Distress  
WJE No. 2021.4581

**4720 Railroad Avenue - Column Distress**

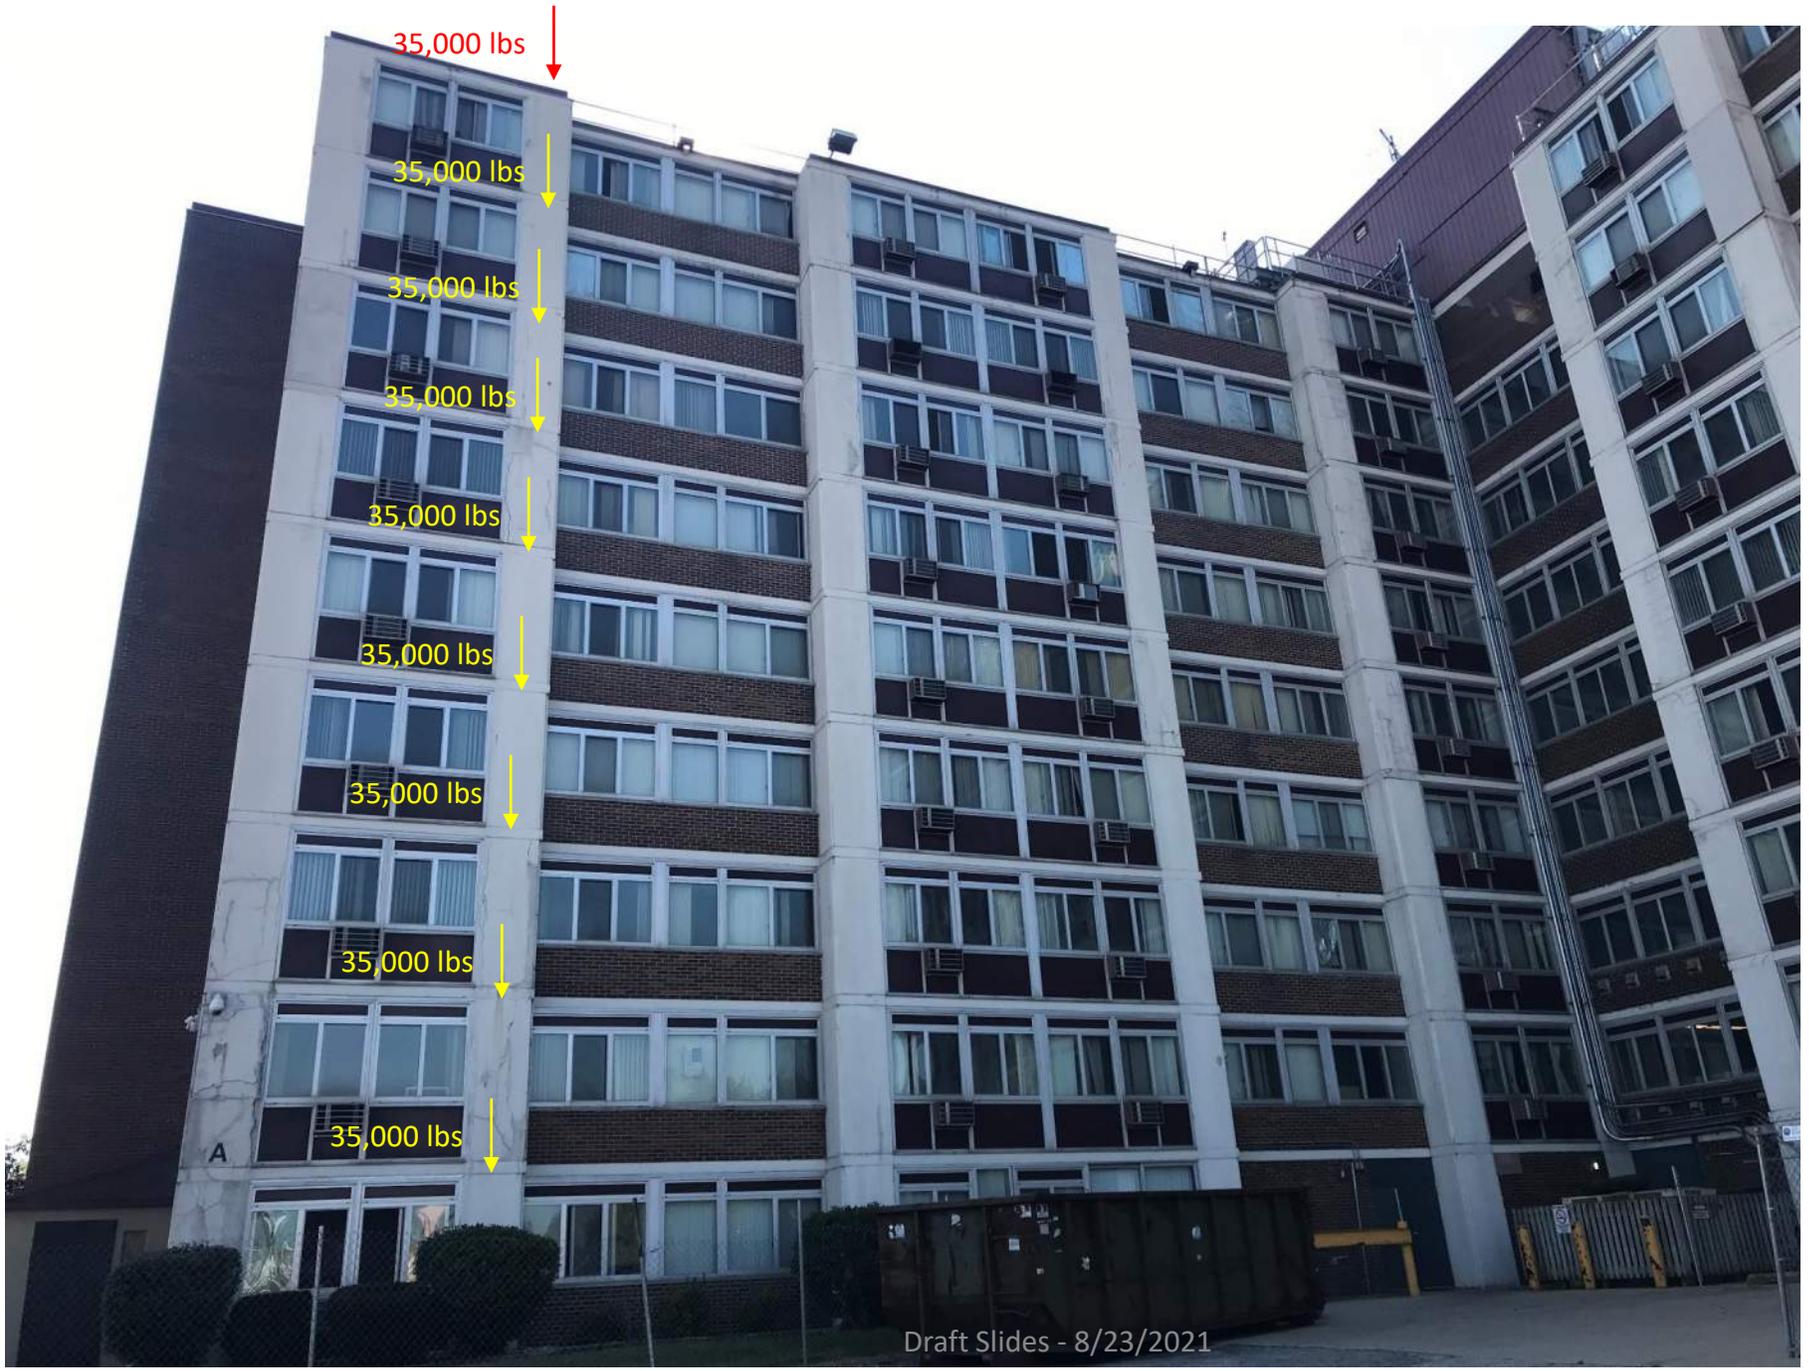
5. Our initial calculations, regarding gravity loads only, indicate that each of the most heavily-loaded exterior columns are required to support approximately 35,000 pounds of unfactored dead load at each floor level from the floor slab and exterior cladding, which results in about 300,000 pounds of unfactored load at the ground floor. Many of the Type B and C columns have experienced deterioration that has compromised their ability to safely support these loads.

35,000 lbs ↓
